Manhole Inspection Summary

Manhole # S35G__031MH

Insp Date: **11/17/08 9:27 AM**

Location Address: **side 201 e baltimore st**

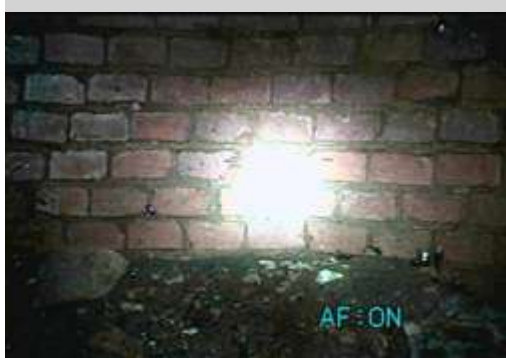
Defect 4

☒ **Debris**

bench debris

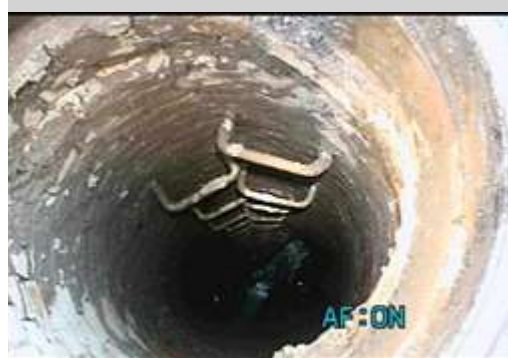
Defect 3

☒ **Wall**

☒ **Corroded**

corbel infiltration, corr steps

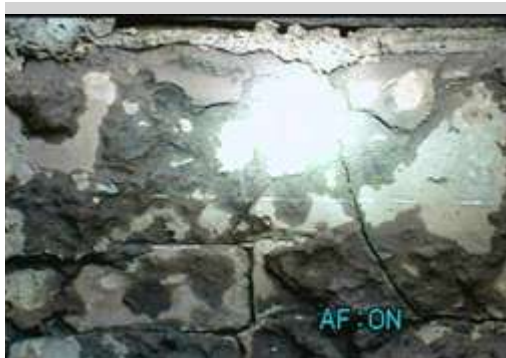
Defect 2

☒ **Cracked**

☒ **Joint**

☒ **Cracks**

cracked chimney and infiltration, frame adj

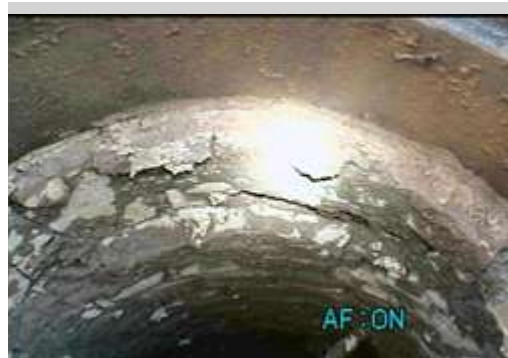
Defect 1

Offset: **2** (in.)

☒ **Leaks**

☒ **Deteriorated**

cracked and deteriorated chimney, infiltration, offset
